Effects of Board Surface Finish on Failure Mechanisms and Reliability of BGAs

Dr. Reza Ghaffarian, Ph.D.
Jet Propulsion Laboratory
California Institute of Technology
Tel: (818) 354-2059
email: Reza.Ghaffarian@JPL.NASA.Gov

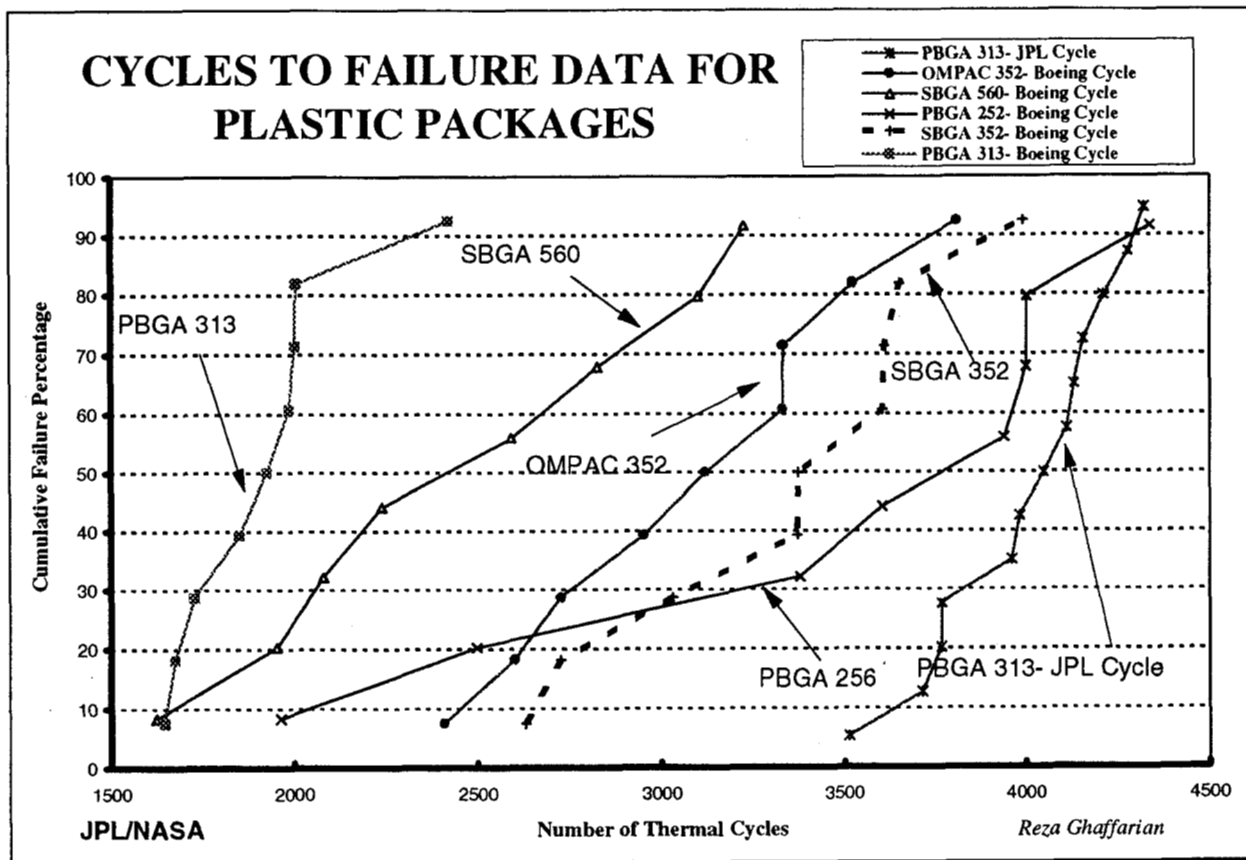
Figure 1 shows cycles to first failure for all plastic packages: PBGA 313 and 256, OMPAC 352, SBGA 352 and SBGA 560. The results are for assemblies on FR-4 and Polyimide PWBs. Preliminary results for two assemblies showed generally higher cycles to failure for polyimide under the B conditions [1]. The most recent PBGA 313 assemblies that failed under the cycle A conditions are also included in the plots for comparison.

Several trends were identified. The PBGA 313, with a depopulated full array with solder balls under the die, were the first plastic packages to show signs of failure at both A and B cycling conditions. The scatter for both was narrow indicating large m Weibull parameter.

The next package assembly failure was SBGA 560. This package and the PBGA 256 with failure data at the extreme cycles showed very large scatter, indicating a low m value. Scatter in PBGAs, in general, could be attributed to slow failure progress. Scatter in failure data for SBGA 560 could be due to the immaturity of the package at the time of use. These packages were taken from those assembled in the early stage of production. The reasons for a large scatter for the PBGA 256 cycles to failure data are not known at this time.

Both OMPAC and SBGA 352 failed at later cycles than SBGA 560 and they were between a low tail for PBGA 313 and a high tail for PBGA 256. The 352 I/O package showed low scatter. Further test results being gathered and analyzed at JPL could shed some light on failure distribution and behavior on various plastic packages.

Figure 1 Cumulative Cycling to Failure for PBGA Assemblies (Cycle B) and PBGA 313 (Cycle A)

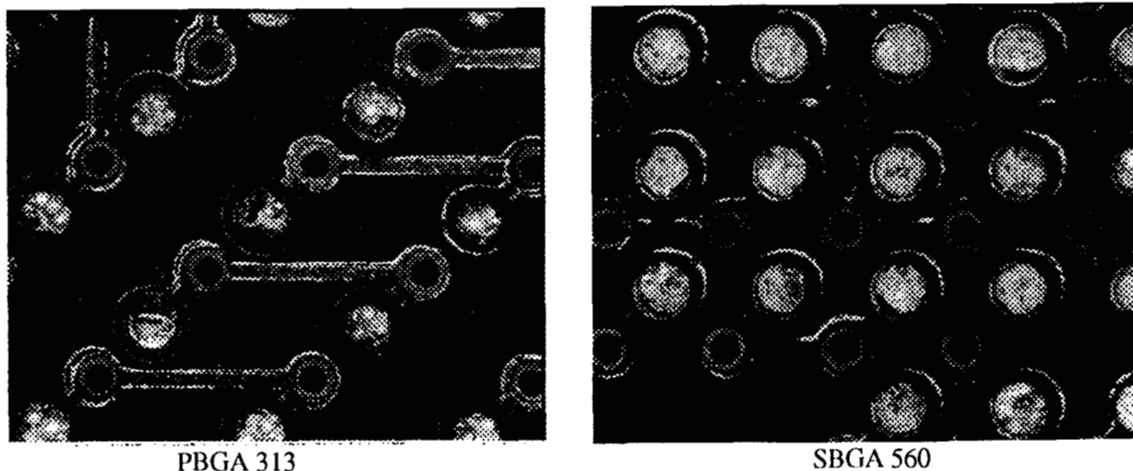
For assemblies under cycle A condition, a SBGA 560 package showed numerous electrical interruptions with signs of electrical opens at an unexpectedly low number of cycles (1,810 cycles). To assure failure, joints were die penetrated and tested to failure in pull testing. Stain on surface represents existence of crack prior to pull test. Fully covered stained area means joint failure. Photos of surface failures for 560 SBGA with stains are compared to a PBGA 313 in Figure 2. There much less stain on SBGA 560 than PBGA 313. Non of detached surfaces of SBGA 560 showed complete stains an indication of no joint failure. Detached surfaces also included a few pad pulling sites. Therefore, it was postulated that failure could have

Figure 2 Crack Propagation (Stained) of PBGA 313 and SBGA 560 after 1,810 A Cycles.

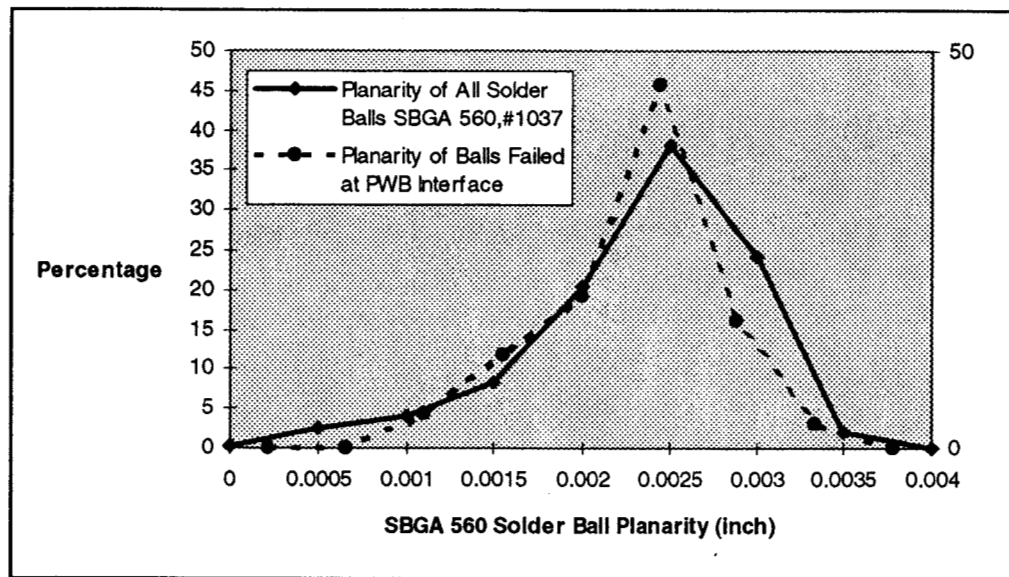
We were able to verify this postulate since we had documented package ball height and location for each package prior to assembly. Solder ball heights were measured using a 3-D laser system. Then, planarity of each ball calculated using the height of the ball minus the height of the virtual seating plane generated by the three tallest balls. The ball planarity distribution for this specific SBGA560 package is shown in Figure 3. This figure also include planarity distribution for joints separated at the board interface.

Planarity distributions for both all balls and those failed from the board under pull test are similar. Planarities were in the range of 0.5 to 4 mils, averaging at 2.5 mils. For this specific package, it was concluded that there was no strong correlation between site separation and solder ball heights. This exercise did not consider the effects of package warpage and its distribution as well as localized board warpage distribution. Most probably either of these variables would have caused a more localized rather than random separation distribution.

Figure 3 Solder Height Variation of Solder Balls for Board and Package Interface Failure for a SBGA

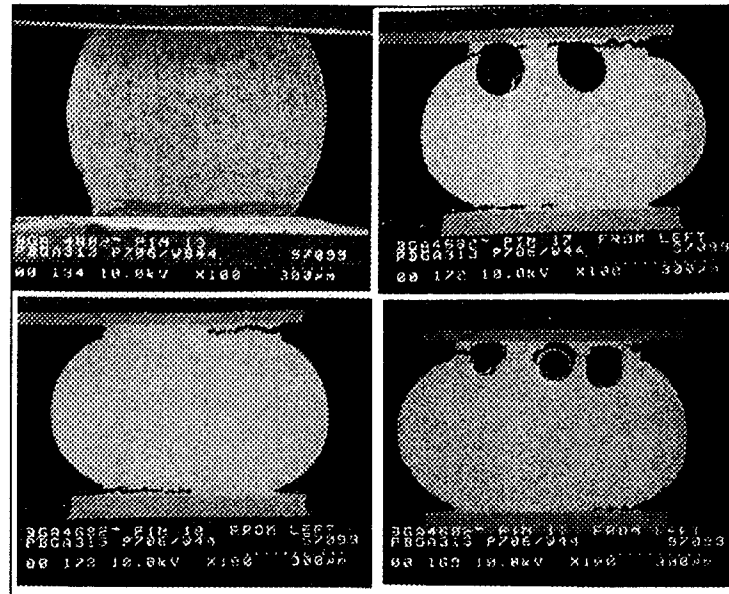
Among the plastic packages, the PBGA 313 with depopulated full array balls was first to fail under both B and A thermal cycling conditions. Figure 6 shows various cross-sections of this package's balls from corner to the center at 4,682 A cycles. These photos are for the balls under the die where most damages occur due to local CTE mismatch. Photos with and without voids were also included for comparison. Voids appear to have concentrated at the package interface under the die. Cracking occurred at package or board interfaces for solder balls with or without voids.

The voids were connected to interface not apparent from photos of cross-section, but it is evidenced from the seepage of mounting materials into voids. Except for the interface connecting cracks, there appeared to be no crack propagation among the voids. The solder joints for this package were also visually inspected to identify indicators of defects. There were none apparent. Even when these were inspected

at 100x by SEM, no gross damage was observed, as evidenced from the top left SEM photo of Figure 4.

Figure 4 SEM and Cross-sections of PBGA 313 after 4,682 cycles under A (-30°C to 100°C) Conditions

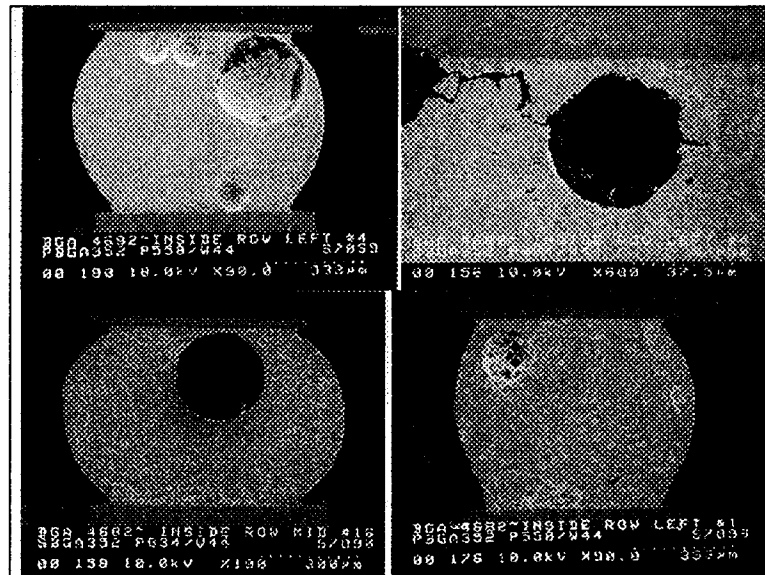
Figure 5 includes a collection of SBGA and PBGA solder joints with voids at different locations in the solder joints. Similarly to PBGA 313, most of voids are close to the package side. There is also an indicator of how cracks propagate in and out of the void. For the upper right hand photo of this figure, a crack initiated at the package interface and propagated into a void at a 45 ° angle. There is another void which is parallel to the package interface. The two types of cracks represent a mix mode stress condition.

Note also that the large void in the lower left photo shows evidence of mounting materials from metallurgic preparation. This is puzzling since there is no evidence of a through-crack. Perhaps a crack, normal to the photograph's cross section, has interconnected the void to the outer balls' surface. Again, this reveals the complexity of failure modes and remind us of caution that must be exercised when interpreting failures by two dimensional cross-sectioning. Ideally, a three dimensional characterization is need to better interpret the results.

Figure 5 Voids in PBGA. Cross-section photos for PBGA 352 and SBGA 352 of Solder Balls with Void and Cracking after 4,682 cycles (-30°C to 100°C)

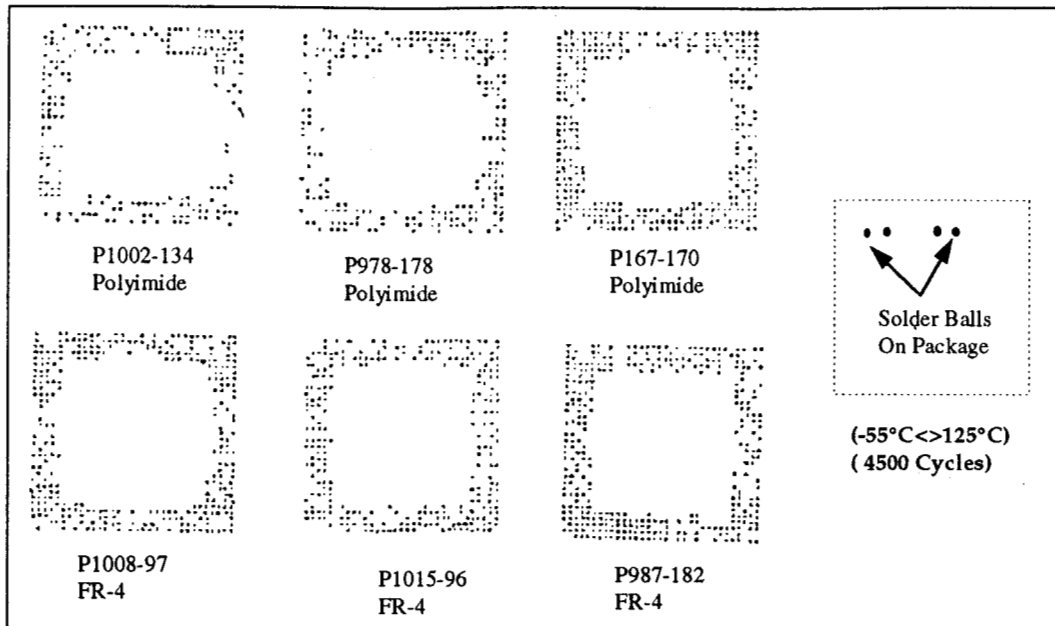
Package attachment were very weak after 4,500 B cycles and were easily detached from the board. Cycled packages were detached and balls were inked and their images were mapped. The ball map distributions for several detached PBGA 313 I/O packages shown elsewhere [2] and for SBGA560 are shown in Figure 6. All joint failures were not from the board interface and there appeared to some trend in their distribution.

Most balls were separated from the board interface for SBGA560 on FR-4 boards as evidenced from the large number of dark spots which represents the balls on the package. This is not true for those on polyimide board. More joint separations at the package side for polyimide

board, might be due to higher thermal stability of polyimide compare to FR-4 in the B thermal cycle.

Note also, separation of one whole edge row from the package side. This might represents the existence of high warpage for outer package edge generally observed for the plastic packages. Similarly, mappings for other plastic packages were carried out and trends were studied.

Figure 6 Map of board/package failure sites for SBGA 560 after 4,500 B cycles. Packages were detached and solder balls on package were then mapped

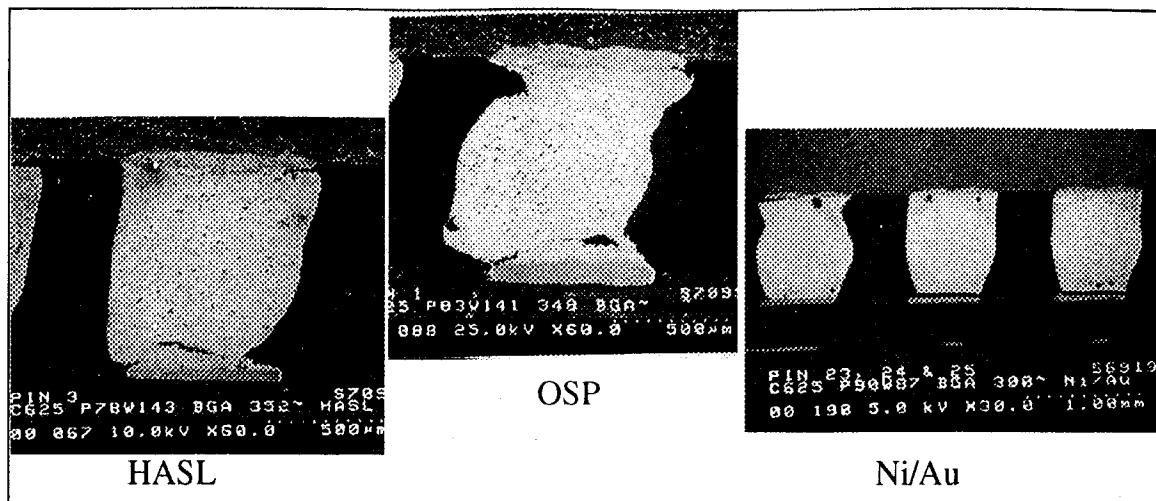
Ceramic package failure under A cycling condition for PWBs with different surface finishes are shown in Figure 7. Both HASL and OSP failures, initiated at the PWB side, showed ductile features evidenced from the zig zag propagation through the eutectic solder joint. Generally, this was not the case for Ni/Au. For Ni/Au, several joints of a package showed brittle failure, which were first noticed during a routine visual inspection of assemblies.

Brittle failure by the gold embrittlement could be one possible explanation, if the amount of gold exceeded three volume percentages of the solder joint. This is not the case, since the thickness of gold was controlled by immersion technique to 3-5 μ inch. To assure this was the case, a sample joint of Ni/Au surface finish was analyzed for various trace elements at PWB interfaces using the Energy Spectroscopy for Chemical Analysis (ESCA) feature of SEM.

Figure 7 Failure Mechanisms for Joints on OSP, HASL, and Ni/Au Surface Finishes for CBGA 625 under A Conditions (-30°C to 100°C)

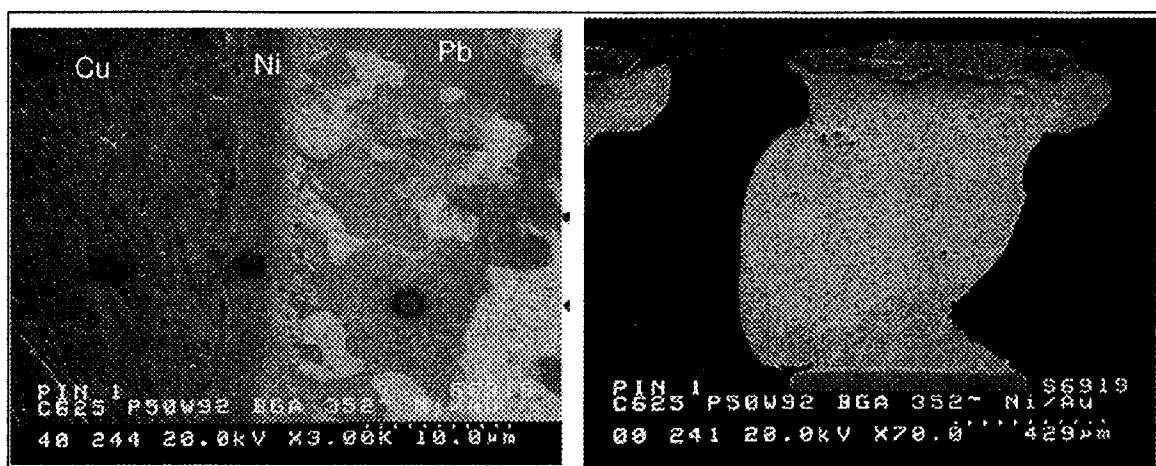
A cross-section photo with elements in each phase shown in Figure 8. Qualitative elements detected by probing at various sections of the joint are also determined. No traces of gold was detected, possibly because the low amount of gold could have been dissolved during the reflow process. Other elements were as expected and included Cu, Ni, P, Pb, and Sn. Existence of phosphorus traces indicates the chemistry of the bath used for Ni plating. This element is found in a common chemistry used for the Ni surface finish.

Figure 8 Magnified Photos of Ni/Au Interface Surface Finish

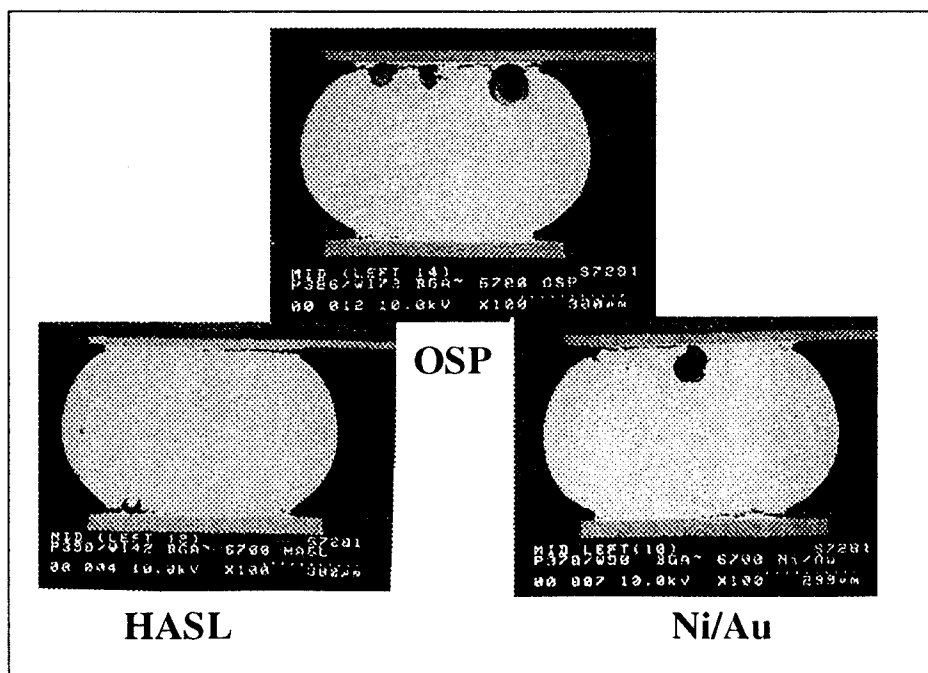
Figure 11, shows cross-sectional micrographs of PBGA 256 after 6,800 A cycles. Photos are for three types of surface finishes, OSP, Ni/Au, and HASL. The failure are very similar to those show previously for assemblies after 4,800 cycles with the OSP finish. There is no apparent differences on failure mechanisms among the three surface finishes. Ductile failure is the principal failure mechanism for the three surface finishes. Similarly to other Plastic packages, failures were either from package or board side. Generally, voids were accumulated at the package interface.

Figure 11 Surface finish and failure for PBGA 256 after 6,700 A cycles

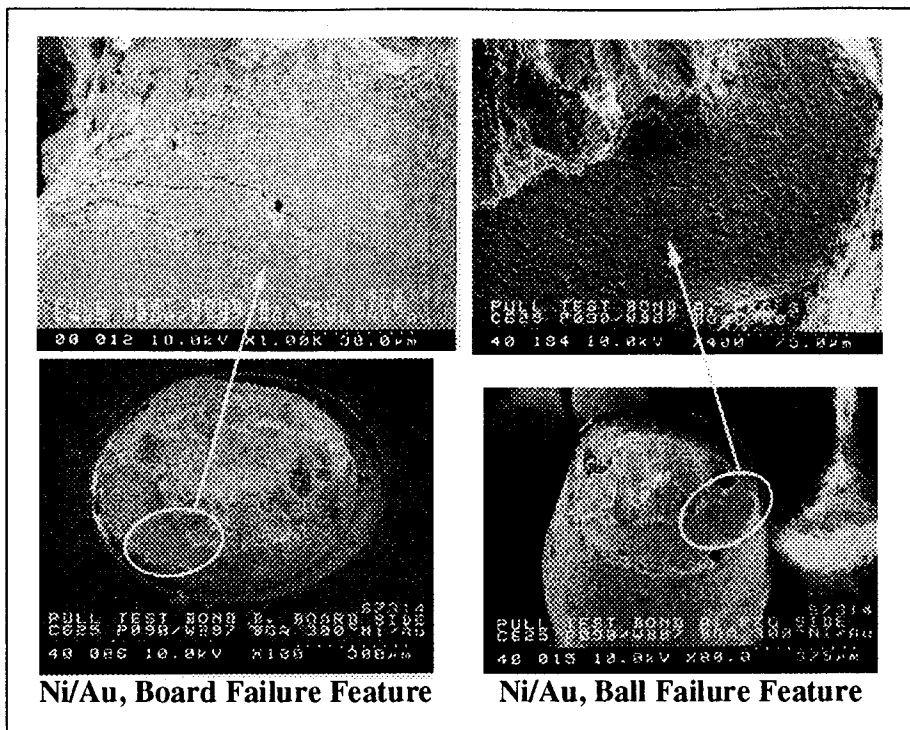
Out of 525 separated balls, only 13 balls remained on board and the majority (525-13= 512) were still attached to package. Out of 512 pad separation on board, 470 were pulled from traces and 42 were by solder joint separation. Out of these 42, only 3 pad showed partial signs of brittle failure. The crescent surfaces were from 1/3 to about 1/4 of the pad area.

Figure 9 shows the SEM photographs for brittle failure feature on ball and package pad. Figure 10 shows elemental analysis of the ball and pad surfaces by ESCA. For ductile failure regions, the elements were Pb and Sn of eutectic solder composition as expected. This was not the case for brittle surfaces. At the smooth ball surface, elements included Ni, P, and Sn whereas at the pad surface, they were mostly Ni. Pimples on the ball surface were Sn.

Figure 9 SEM photomicrograph of detached of ceramic package on Ni/Au surface finish with brittle areas

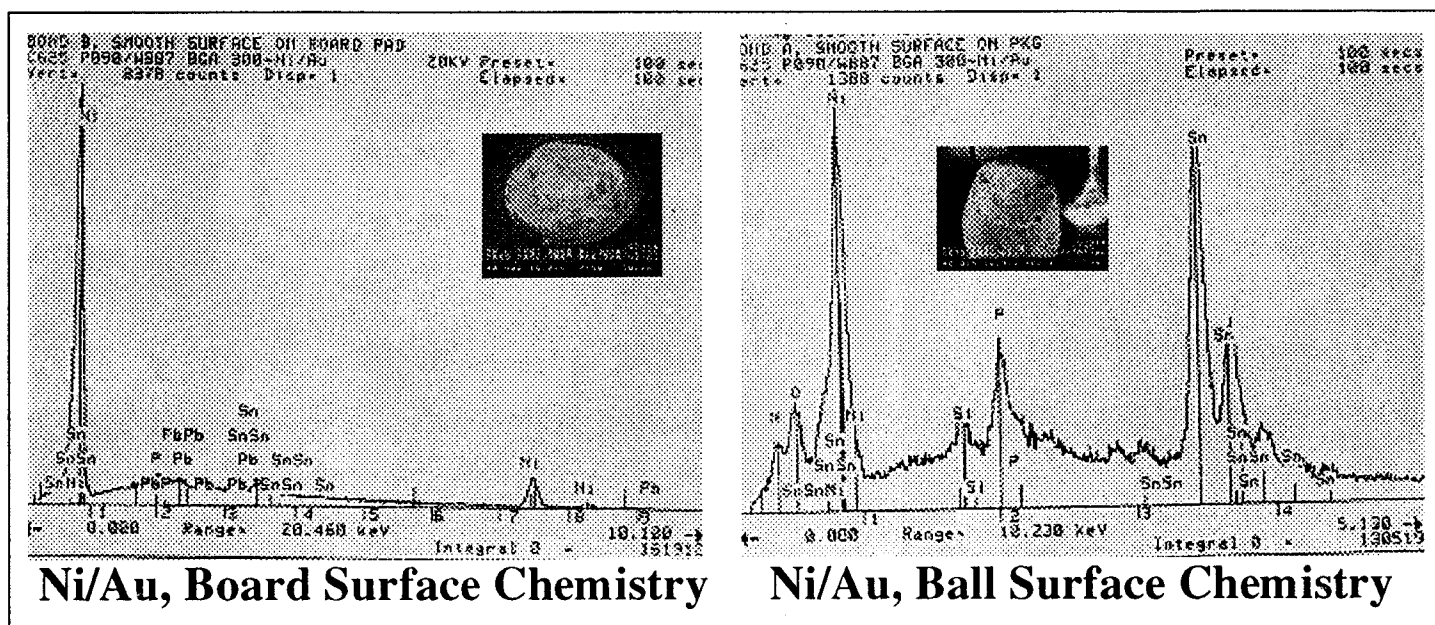
Figure 10 Elemental chemistry of brittle surface shown in Figure 9
